Pump and Mixer Specialists

Location: **City of Anywhere**
 Date: **December 1, 2009**

Area:	General
Equipment:	Raw Sewage Pump 1

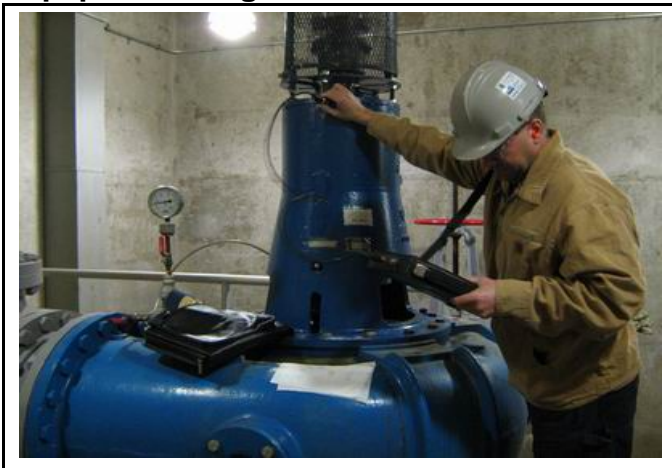
Raw Sewage Pump 1

Vibration on this unit is low and acceptable.

There are no mechanical faults on this equipment.

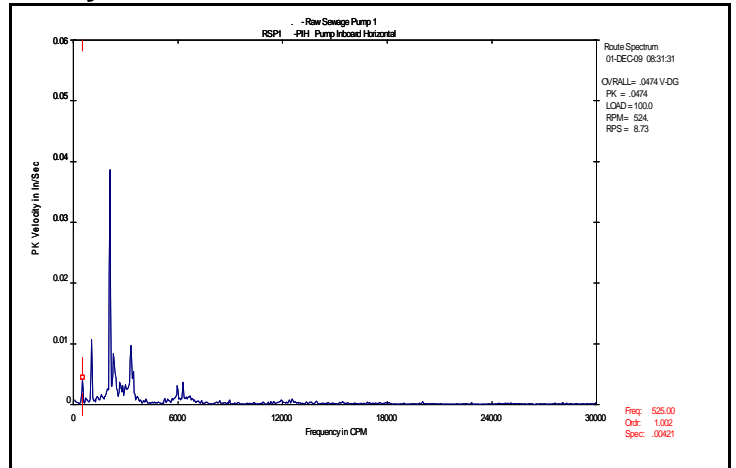
Vibration Spectrum

Parameters	Values
Vibration (ips)	0.05 ips
Vibration (g's)	0.5 g
Temperature	No issues
Operating Speed	524 rpm

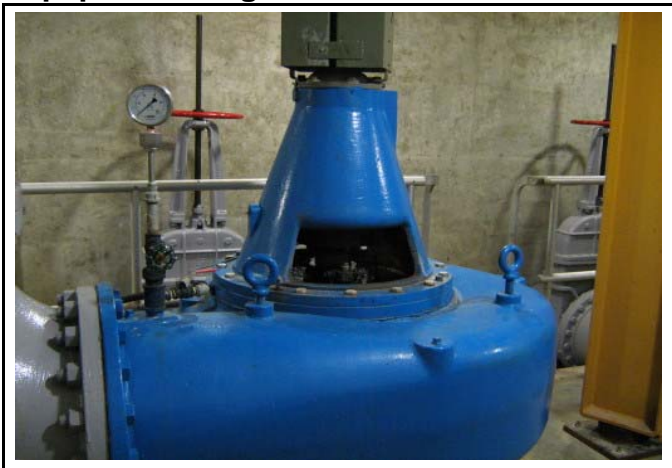
Raw Sewage Pump 3

Vibration on this unit is low and acceptable.

There are no mechanical faults on this equipment.

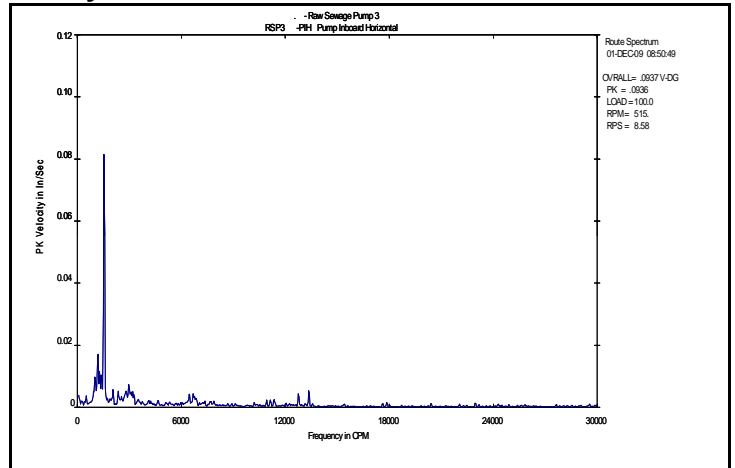
Vibration Spectrum

Parameters	Values
Vibration (ips)	0.09 ips
Vibration (g's)	0.6 g
Temperature	No issues
Operating Speed	515 rpm

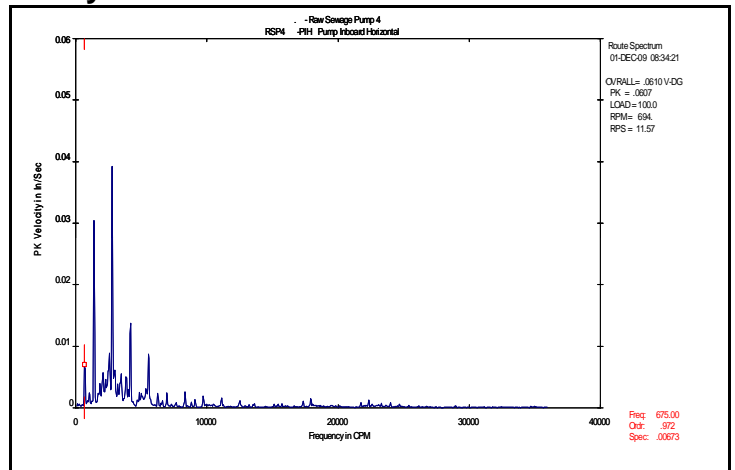
Vibration Spectrum

Vibration on this unit is low and acceptable.

Parameters	Values
Vibration (ips)	0.06 ips
Vibration (g's)	0.1 g
Temperature	No issues
Operating Speed	694 rpm

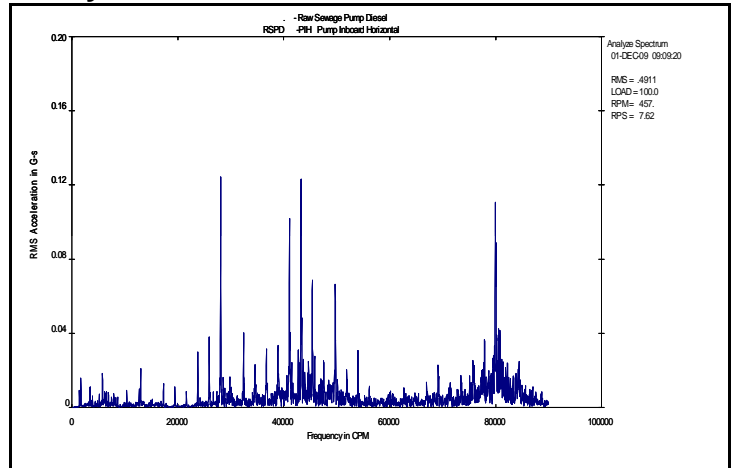
Vibration Spectrum

Vibration on this unit is quite low however the pattern on the pump indicates non-synchronous energy likely related to a dry bearing or early stage bearing fault. Please insure this pump's bearing are adequately lubricated prior to next visit.

Parameters	Values
Vibration (ips)	0.08 ips
Vibration (g's)	0.7 g
Temperature	Not run long enough
Operating Speed	457 rpm
